Assessment of Asphalt Interlayer Designed on Jointed Concrete

**Final Report
November 2014**

Sponsored by
Iowa Department of Transportation
(InTrans Project 13-475)
Federal Highway Administration

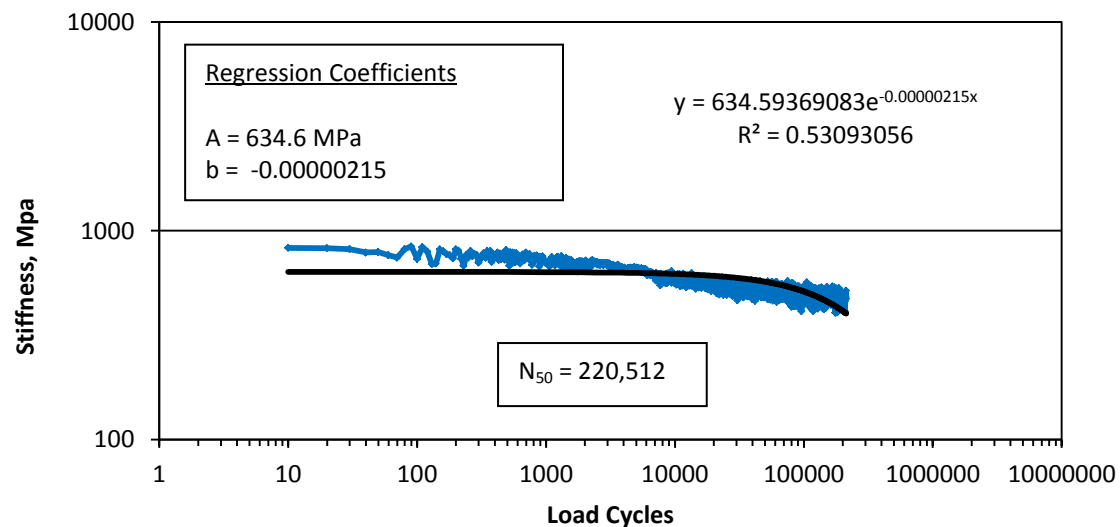
Figure 4. Stiffness versus load cycles (repetitions), beam-2

The asphalt mix design using the high-polymer modified binder passed the 100,000 load cycle requirement in the four-point bending beam (Figure 2). A regression analysis of the flexural stiffness data was performed in accordance with AASHTO T-321 on each of the two beams that were tested (Figures 3 and 4).

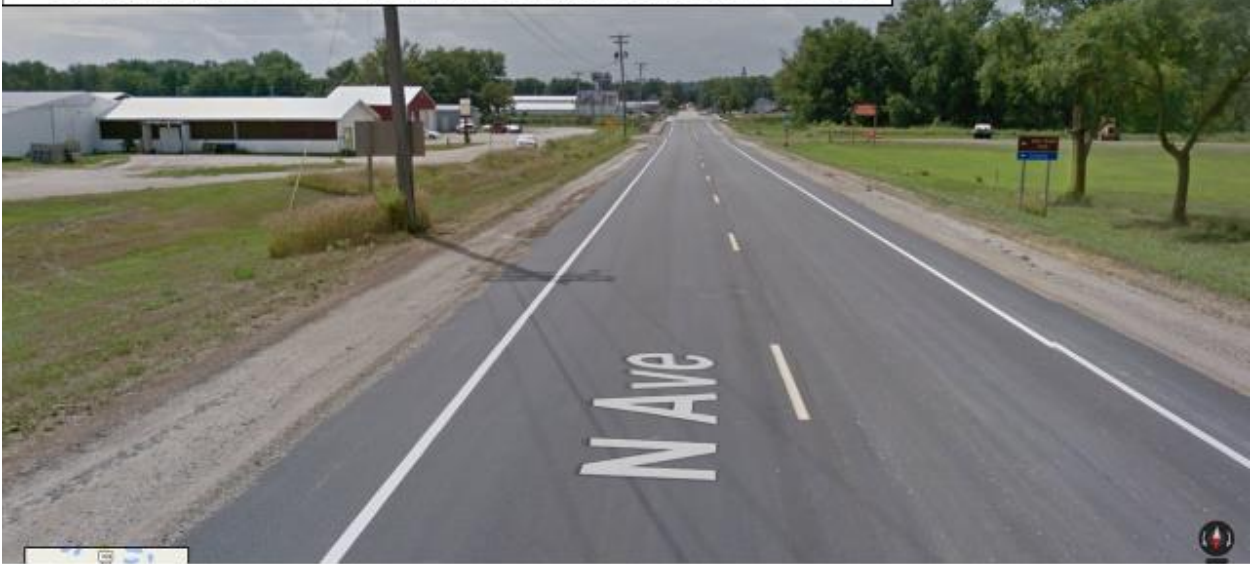
- South end of project looking south
- Non-interlayer section after paving intermediate course

Figure 9. Post-construction view of intermediate course in non-interlayer section on US 169

In the non-interlayer pavement section, the intermediate course overlay is two inches thick. The screen capture shows the intermediate HMA course to be in good condition.

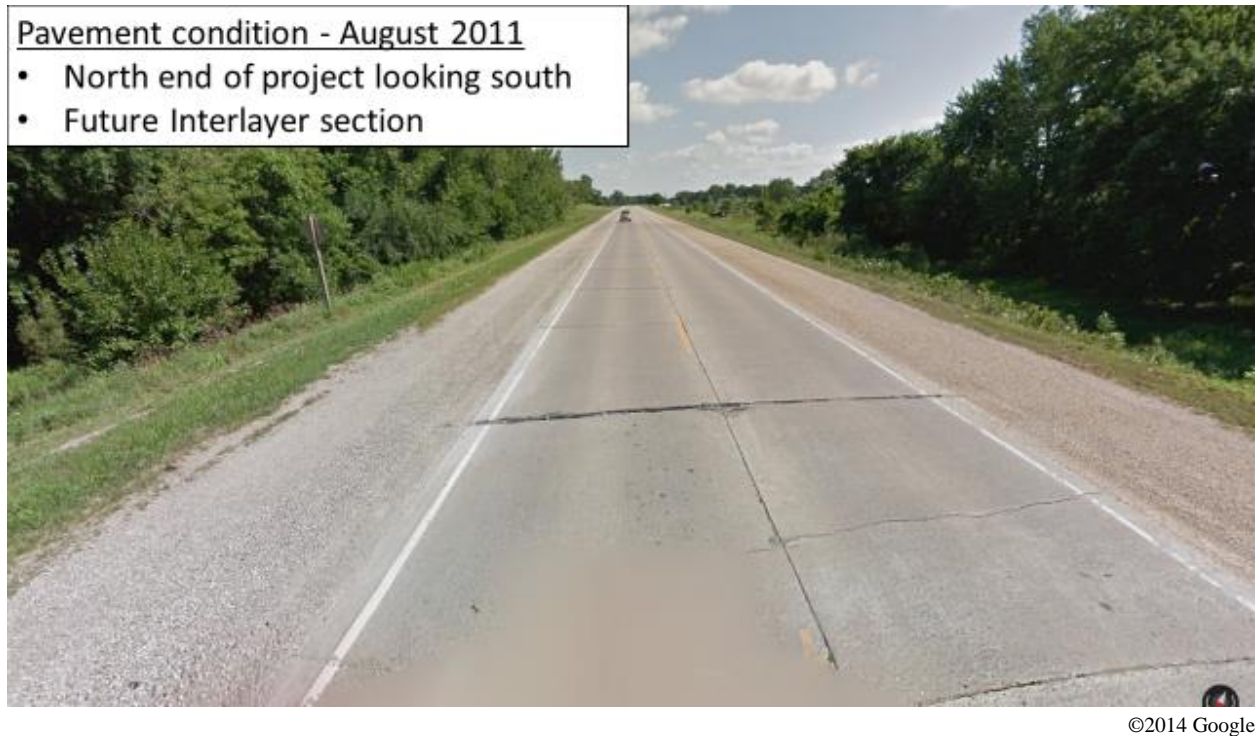
Figure 10. Pre-construction view of interlayer overlay section on US 169

In Figure 10, a high level of joint deterioration can be seen in the future interlayer section. And unlike the non-interlayer section, the intermediate course is already cracking in the same construction season (Figure 11). The difference between the two different overlay sections is the thickness of the intermediate course. The intermediate course in the interlayer section was only one inch thick, not two inches thick, to provide room for the interlayer. This demonstrates just how quickly reflective cracks form in thin overlays (one inches) and is precisely the reason why overlays for distressed PCC pavements are designed to have a certain minimum thickness. In the case of this project, the overlay thickness design was four inches. However, by waiting several weeks between construction of the intermediate course and the surface course, the one-inch course was thin enough to crack prior to paving the second lift.

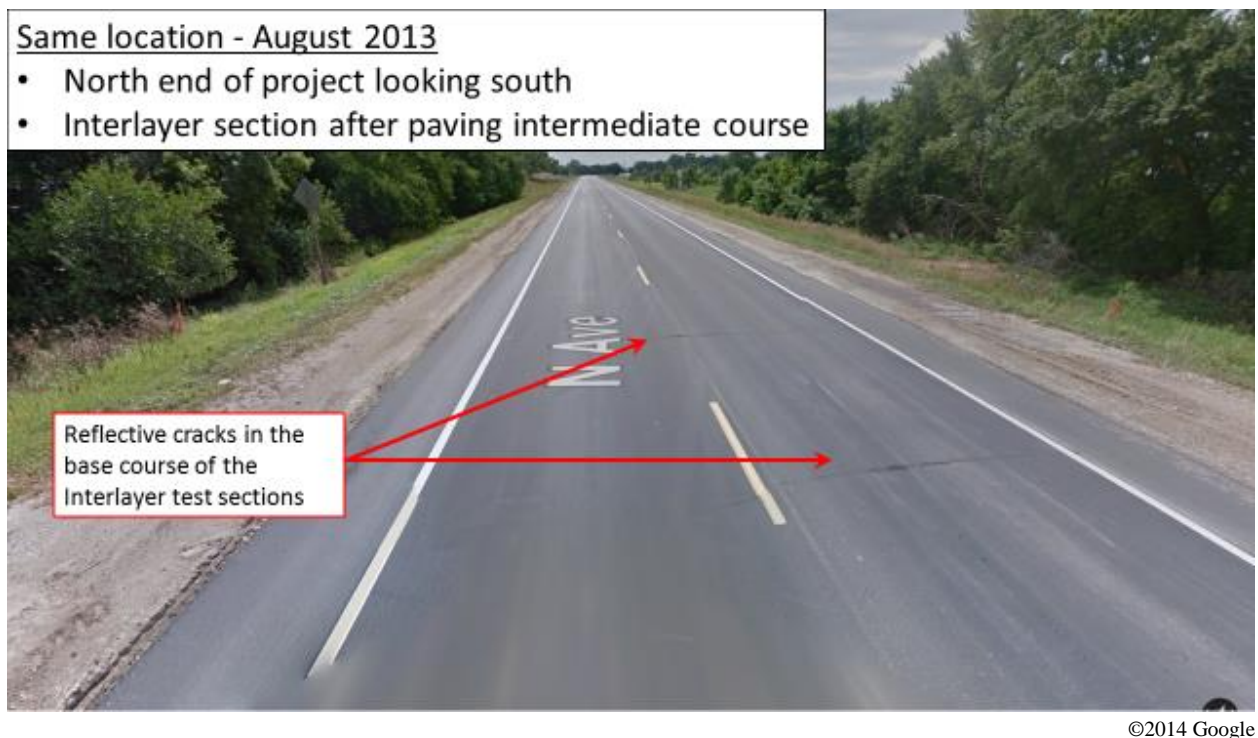
Figure 11. Post-construction view of intermediate course in interlayer section on US 169
